USS ARIZONA MEMORIAL and PEARL HARBOR NATIONAL HISTORIC LANDMARK

SUBMERGED CULTURAL RESOURCES STUDY

by Daniel J. Lenihan, Editor Principal Investigator Submerged Cultural Resources Unit

Southwest Cultural Resources Center Professional Papers No. 23

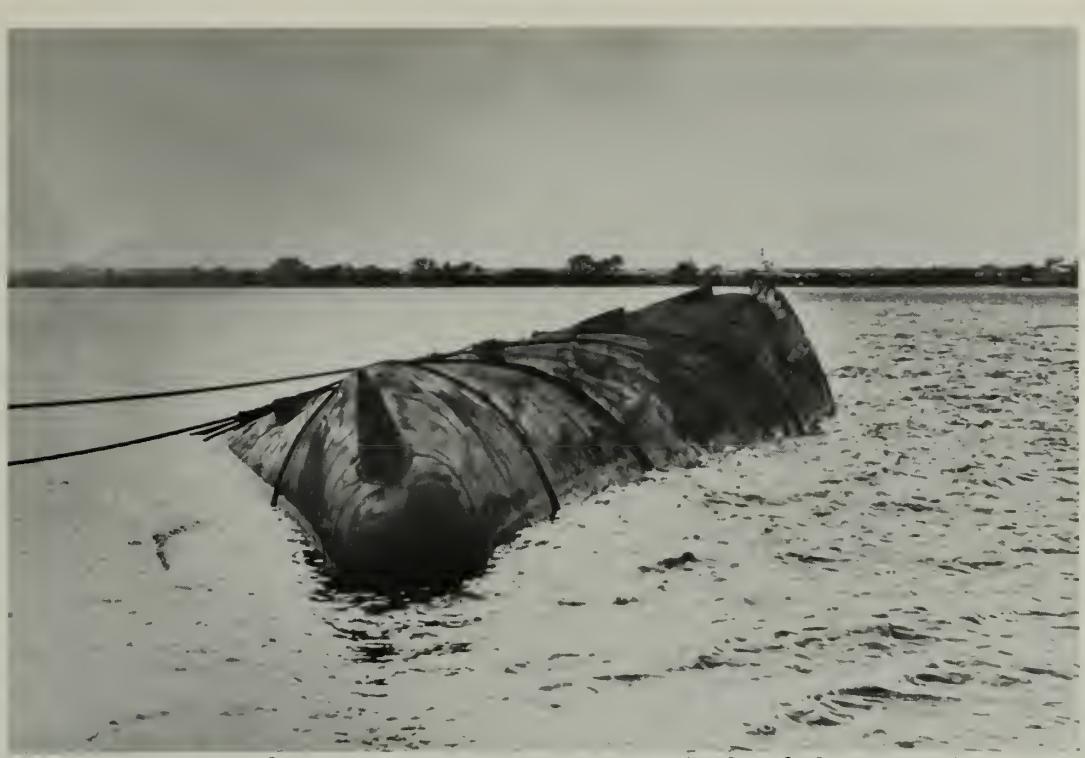
Figure 2.38. The USS UTAH turned turtle after attack. (NPS: USAR collection)

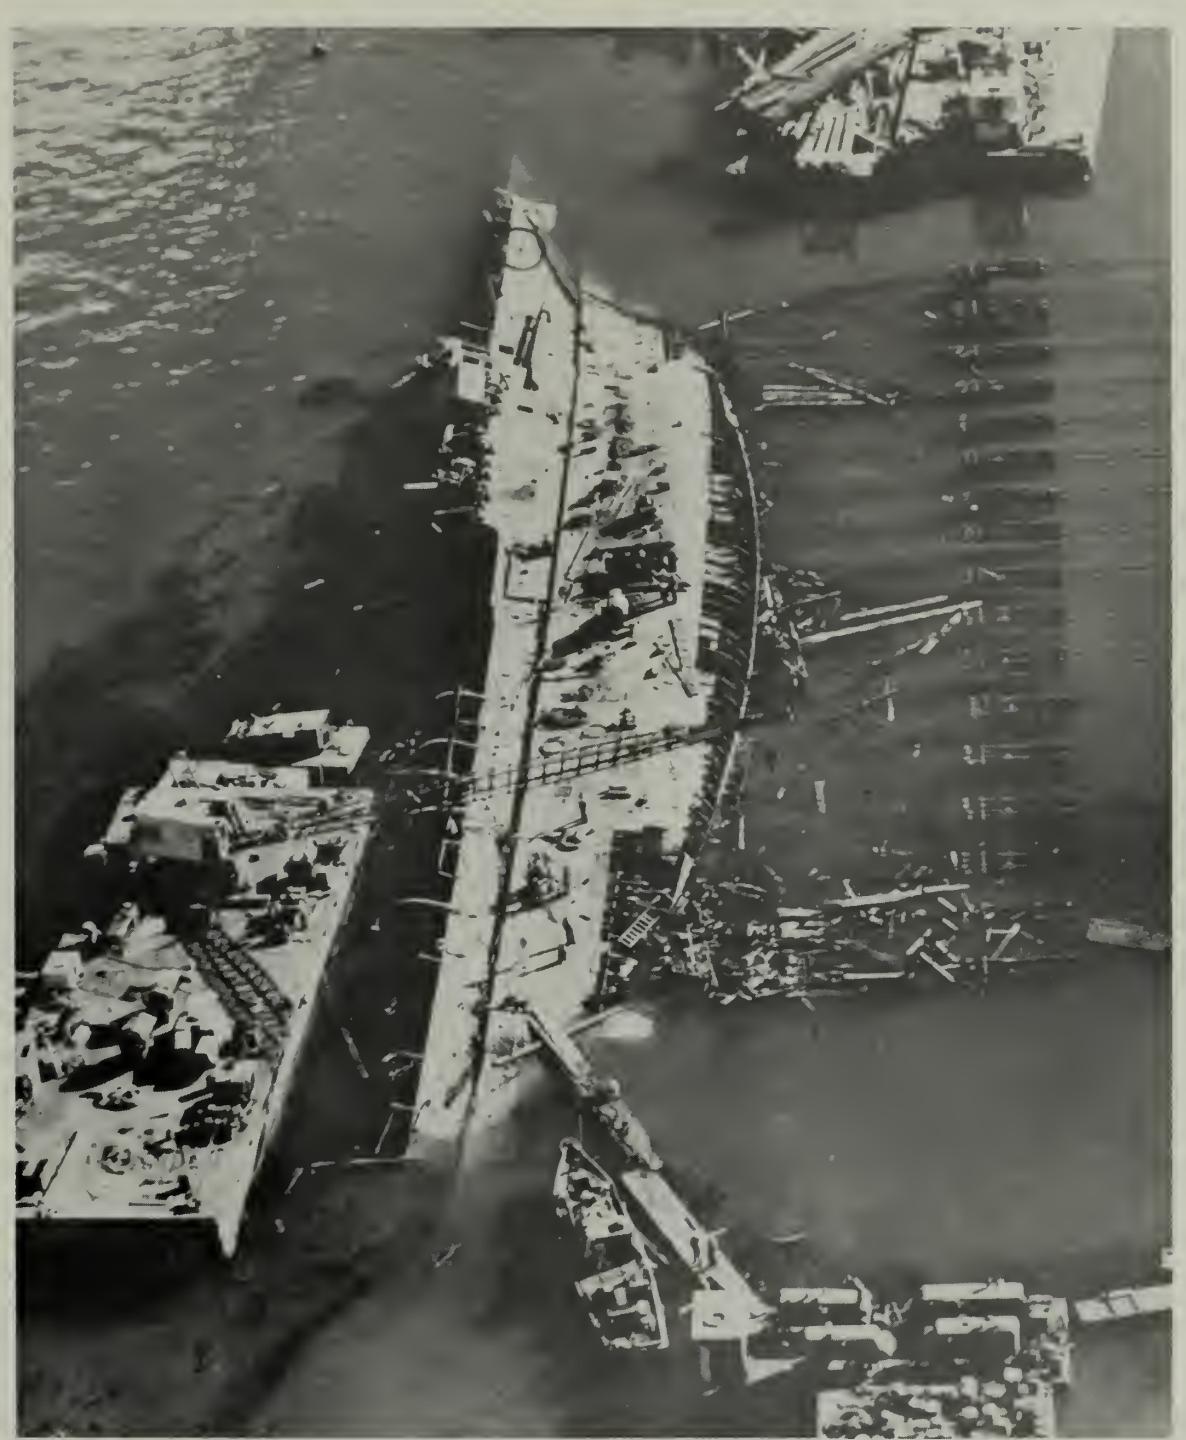
Figure 2.40. The UTAH partially righted during salvage operations. (NPS: USAR collection)

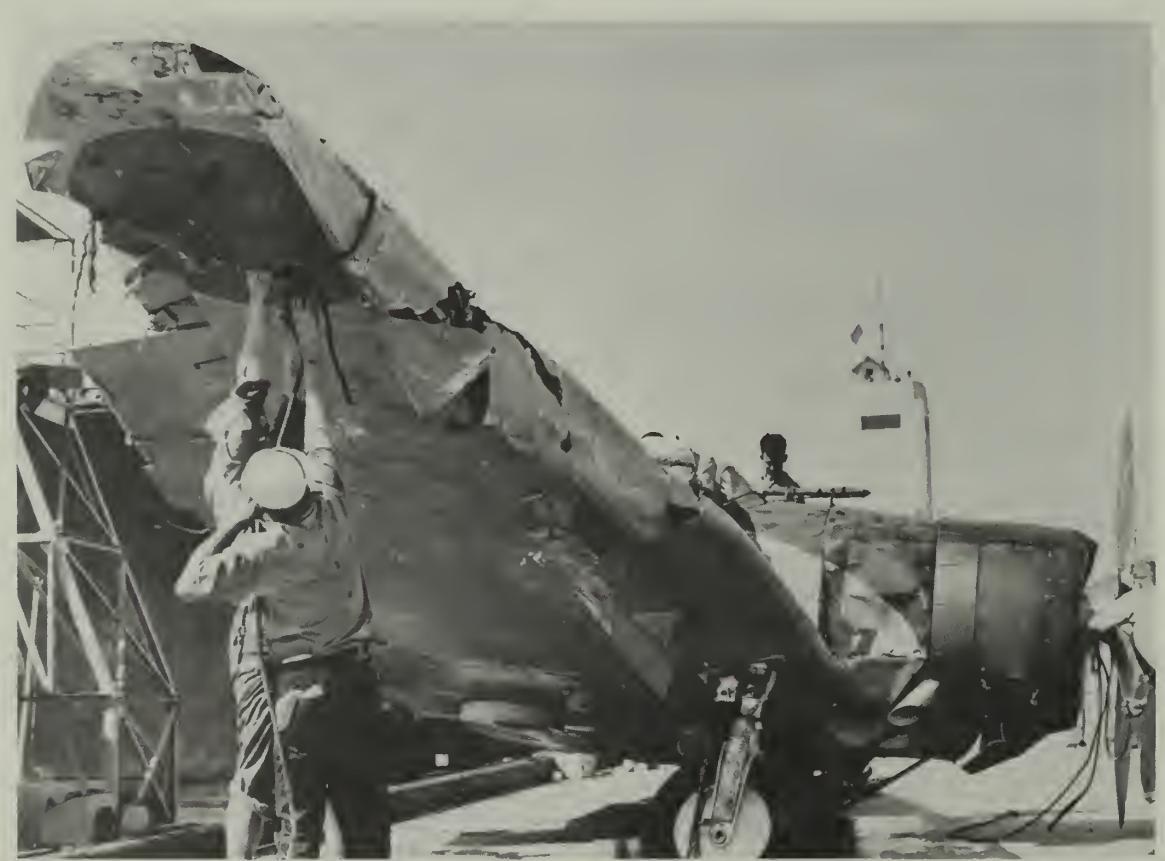
Figure 2.42. Close up of "Val" that crashed during the attack. (NPS: USAR collection)

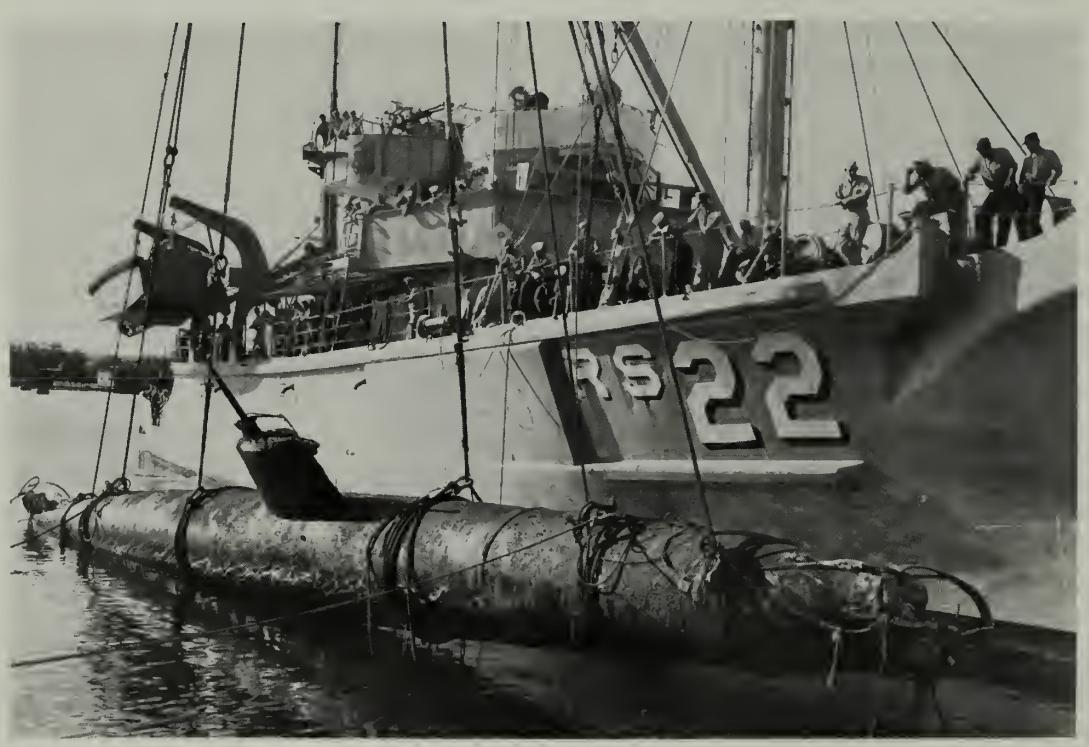
Figure 2.44. One of the midget subs being removed from the bottom in 1960. Note torpedoes still in tubes. (NPS: USAR collection)

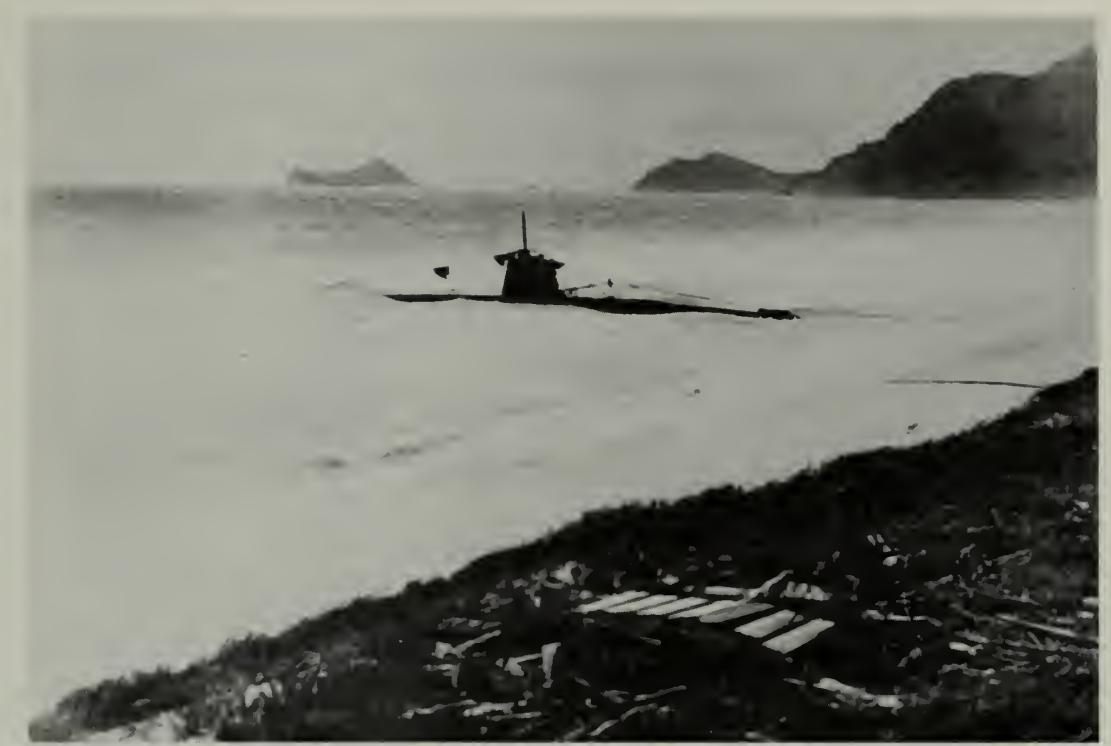
Figure 2.45. Japanese midget submarine HA. 19 beached at Bellows on the northern or windward side of Oahu. Photo by Signal Corps (NPS: USAR collection)

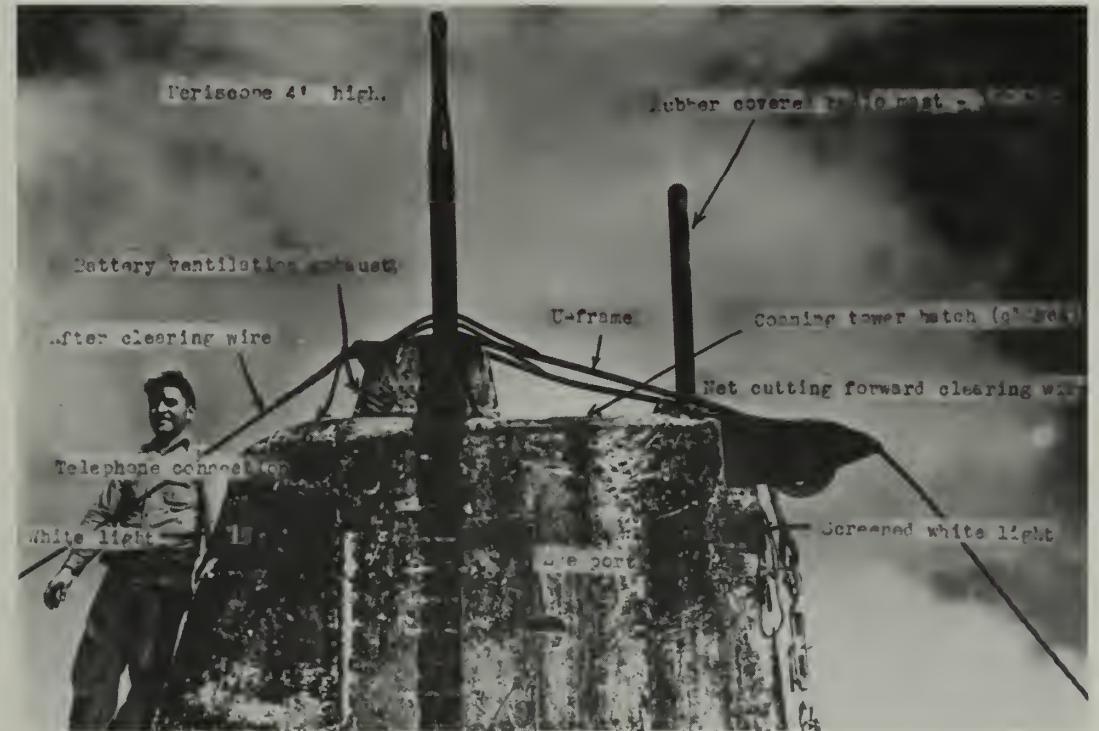
Figure 2.46. Conning tower of Japanese midget submarine HA. 19. (NPS: USAR collection)

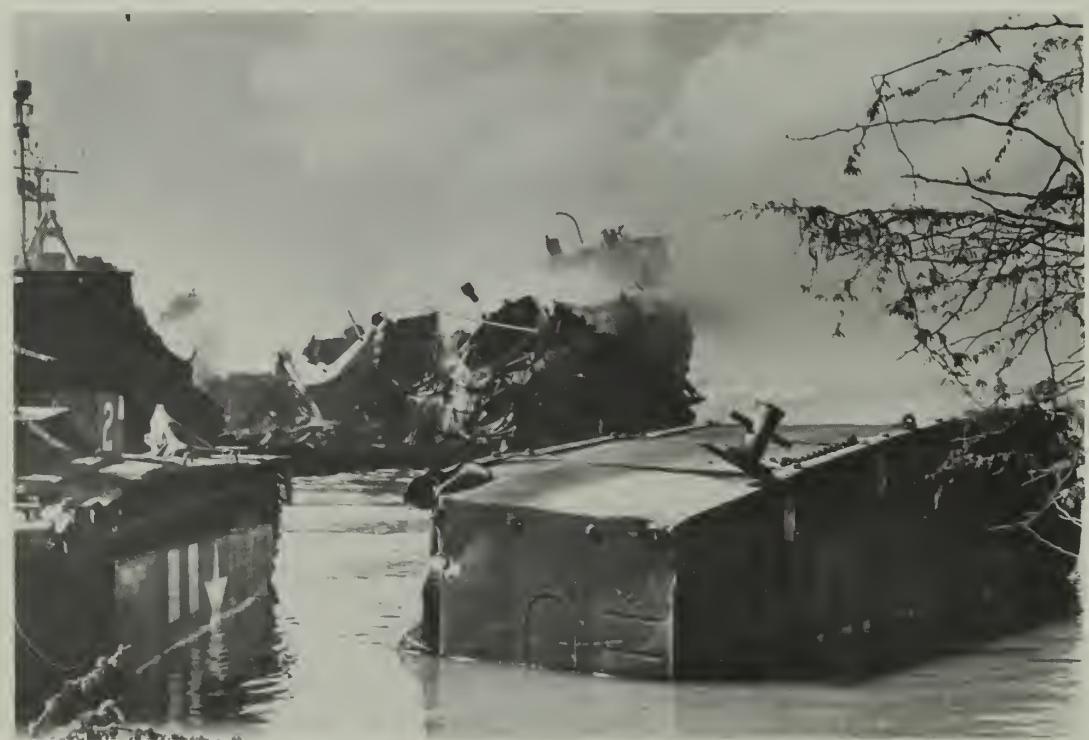
Figure 2.50. Aftermath of West Loch explosions (NPS: USAR collection)

In all six LSTs were sunk and several severely damaged. Dead were 163 men and 396 were wounded.

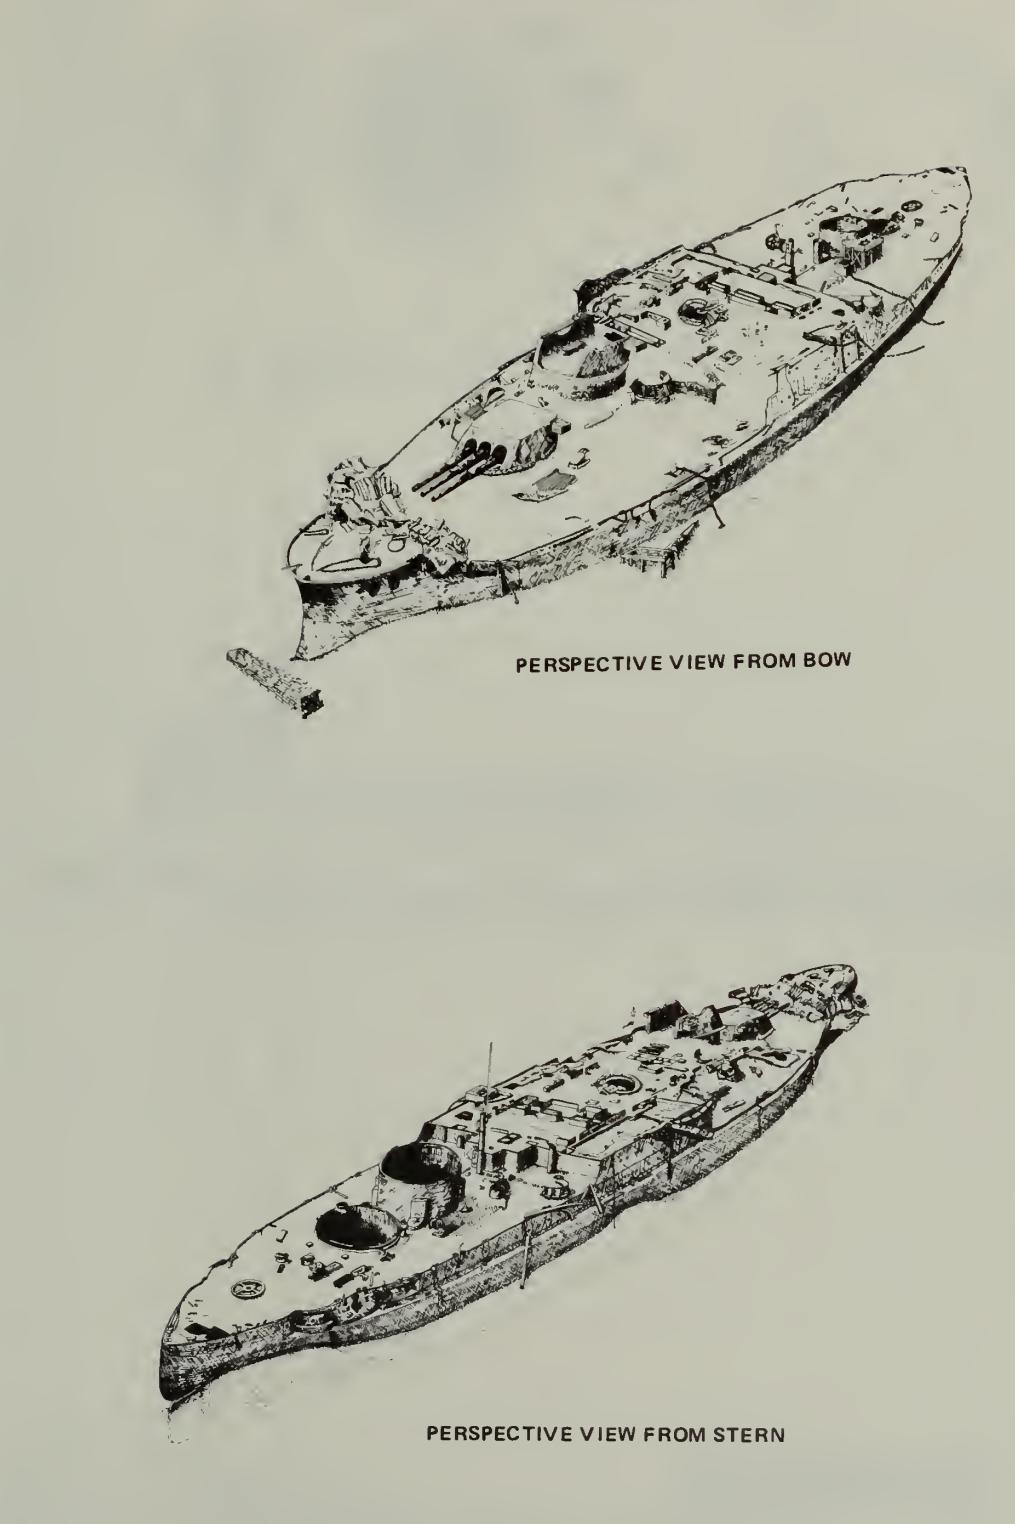
Extensive salvage operations are recorded in the bow area. The remains of the forecastle deck and main deck were cut away and removed, and mud was pumped out of the area. The salvage log records much cutting on the second and third decks and the forward bulkheads. The magazine explosion clearly damaged the lower deck areas aft as far as the No. 2 turret. Navy salvage divers were unable to enter sections of No. 2 because passageways were blocked with wreckage. The explosion apparently collapsed bulkheads supporting the No. 1 turret, which still remains onsite, and the turret rests 15 feet lower than its original position.

On the port side approximately 80 feet and 112 feet aft of the stem, open cracks visible in the torpedo blister continue below the silt line. These cracks in the sides above the silt probably indicate a major structural failure associated with the magazine explosion. In all probability the inner hull and armor belt are also cracked.

Figure 3.7. These artistic renderings by Jerry Livingston portray the ship remains from different oblique angles.

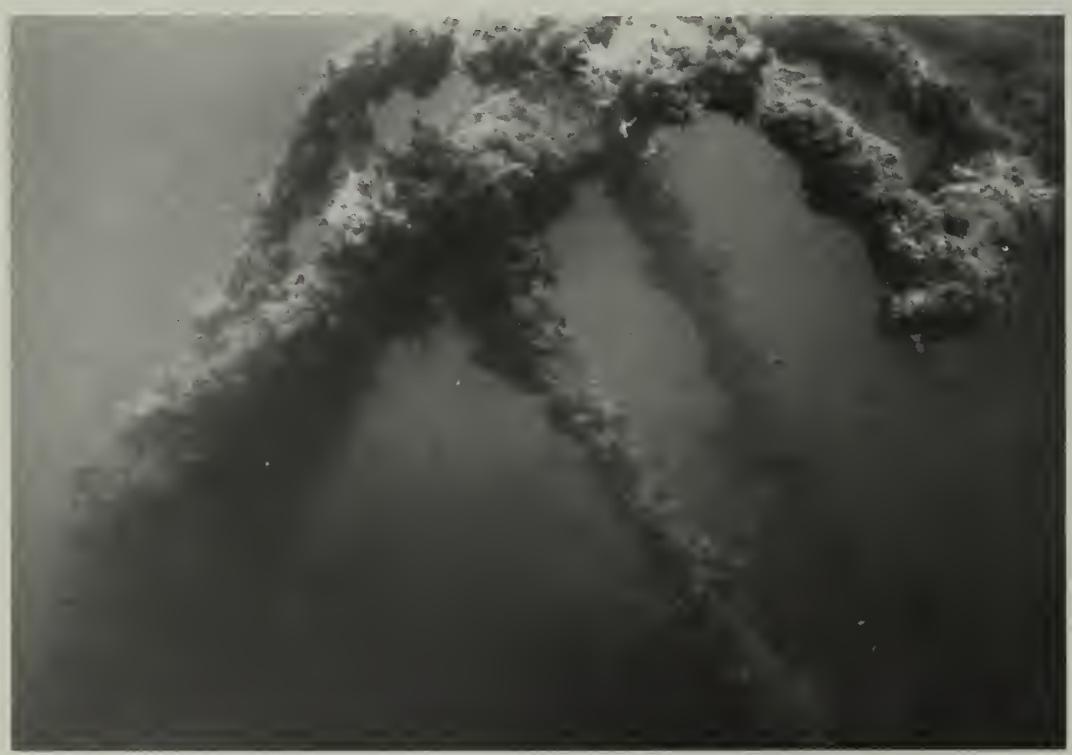
Figure 3.12. Awning cover for a hatch on aft port side of No. 1 turret. (NPS photo by Larry Murphy)

Along the sides of turret No. 1 below the range finders, teak decking -- the forward remains of the forecastle deck -- is visible after light fanning of the silt. A few feet farther aft on the port side is a hatch that has been propped open for access below decks, probably by the salvage teams (Figure 3.12). The tropical awning support is in place.

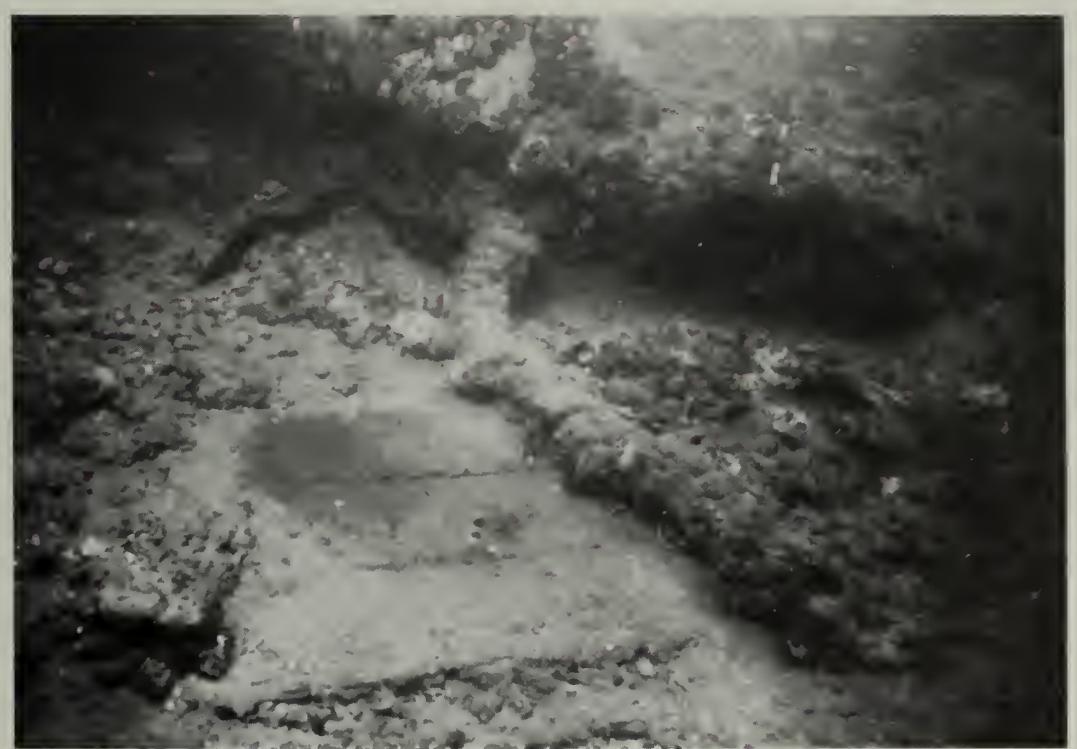
Figure 3.14. Intact teak decking is exposed on USS ARIZONA. (NPS photo by Larry Murphy)

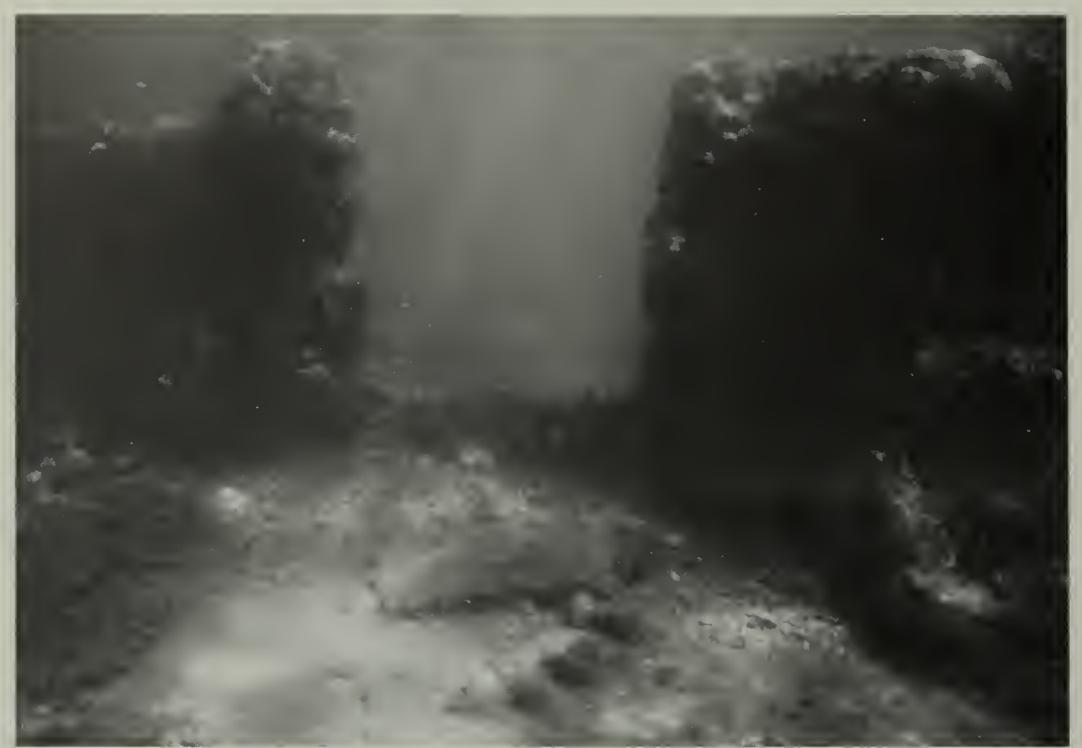
Figure 3.15. Entryway to galley and mess area, with bulkheads partially removed. (NPS photo by Larry Murphy)

The remains of bulkheads and other features unmistakably define the galley area (Figure 3.15). Doorways, oven bases and what appear to be table legs are visible. The floor was covered with 2-inch hexagonal tile, much of which remains beneath the thin layer of silt. Many artifacts can be found, including coffee cups, plates and silverware (Figure 3.16). The stumps of the main mast tripod legs are discernible, as are the bases of boat cranes.

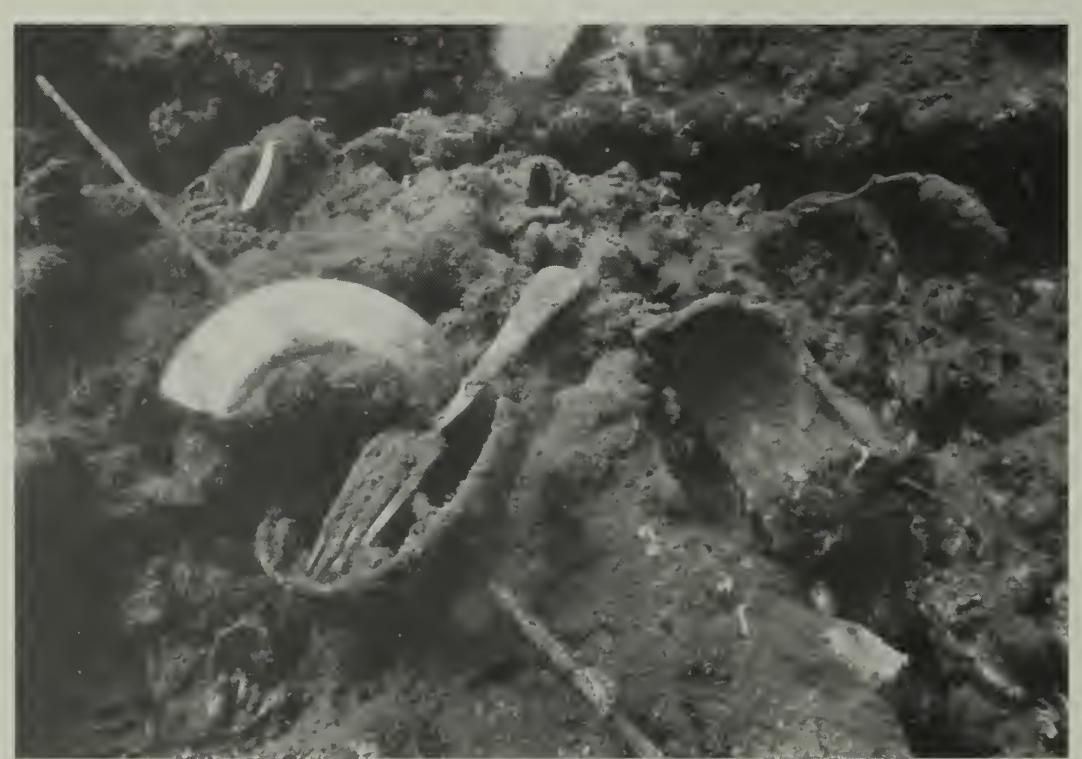
Figure 3.16. Artifacts in ship's galley area, USS ARIZONA. (NPS photo by Larry Murphy)

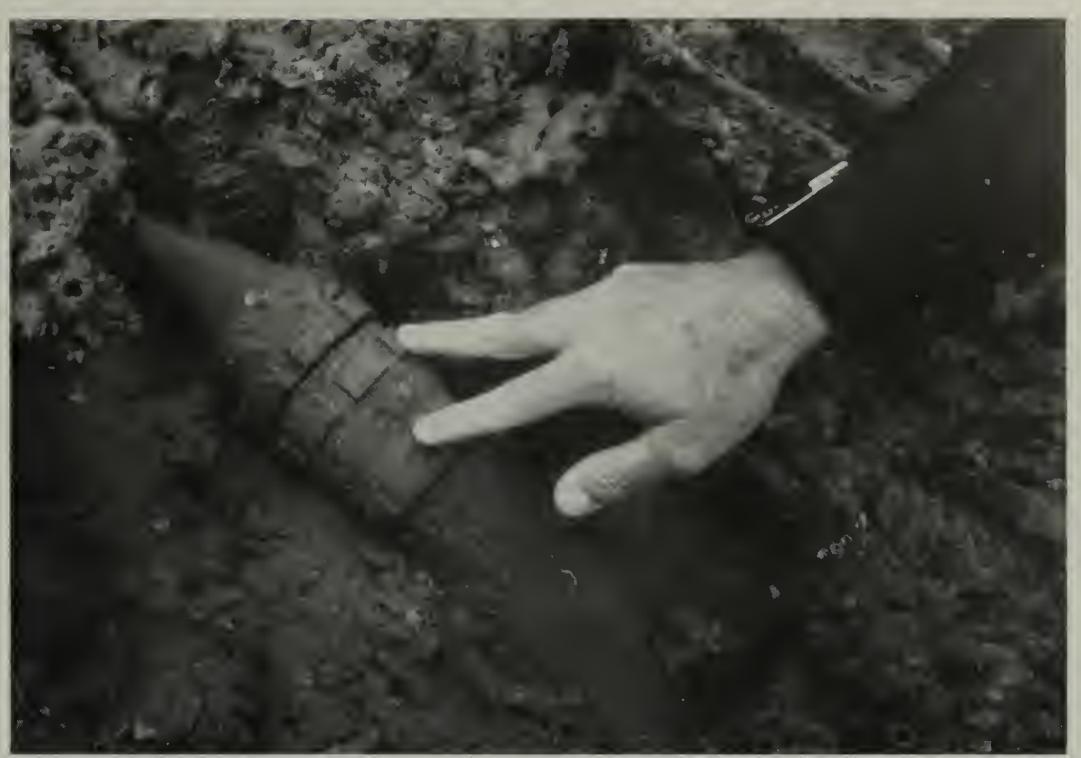
Figure 3.17. Coupling of fire hose on deck of ship protrudes through the sediment. (NPS photo by Larry Murphy)

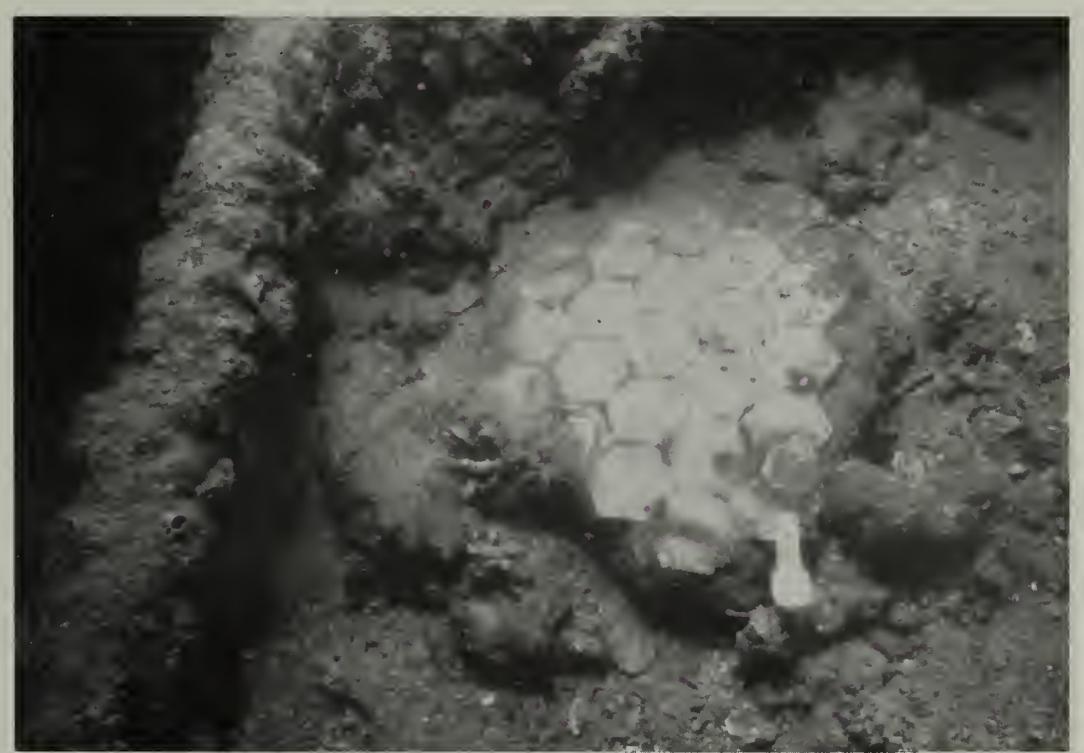
Figure 3.18. Tile floor in galley area of USS ARIZONA. (NPS photo by Larry Murphy)

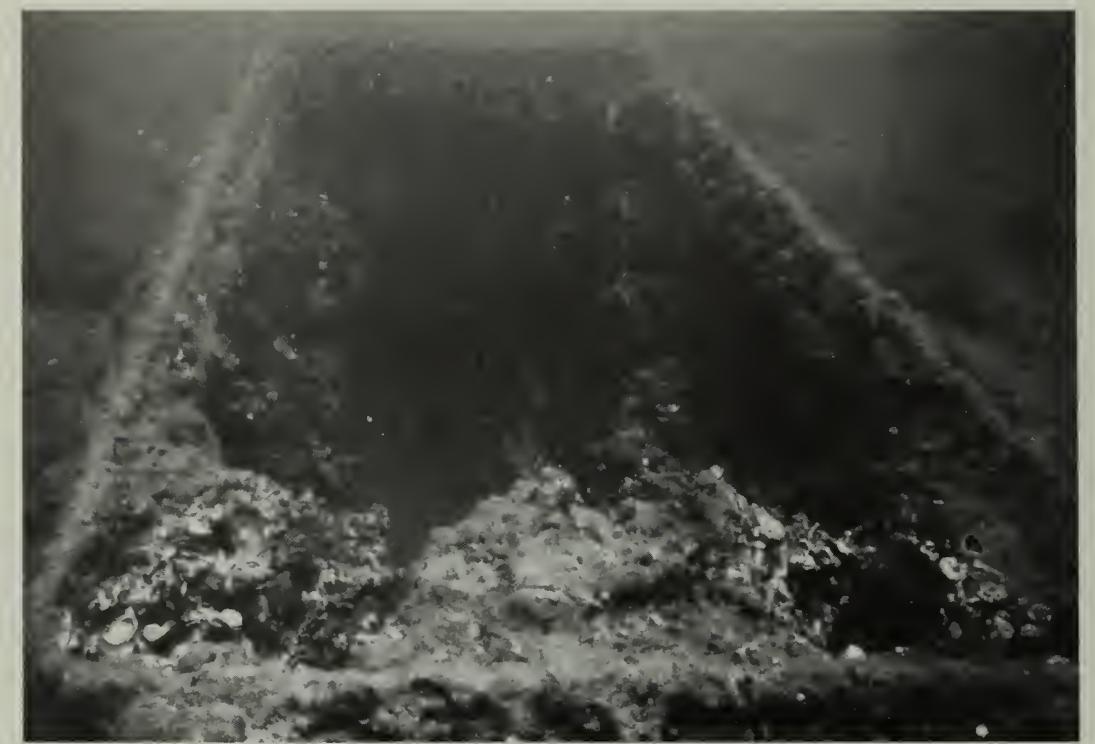
Figure 3.19. Open hatch on USS ARIZONA with stairwell heavily fouled with marine organisms. (NPS photo by Larry Murphy)

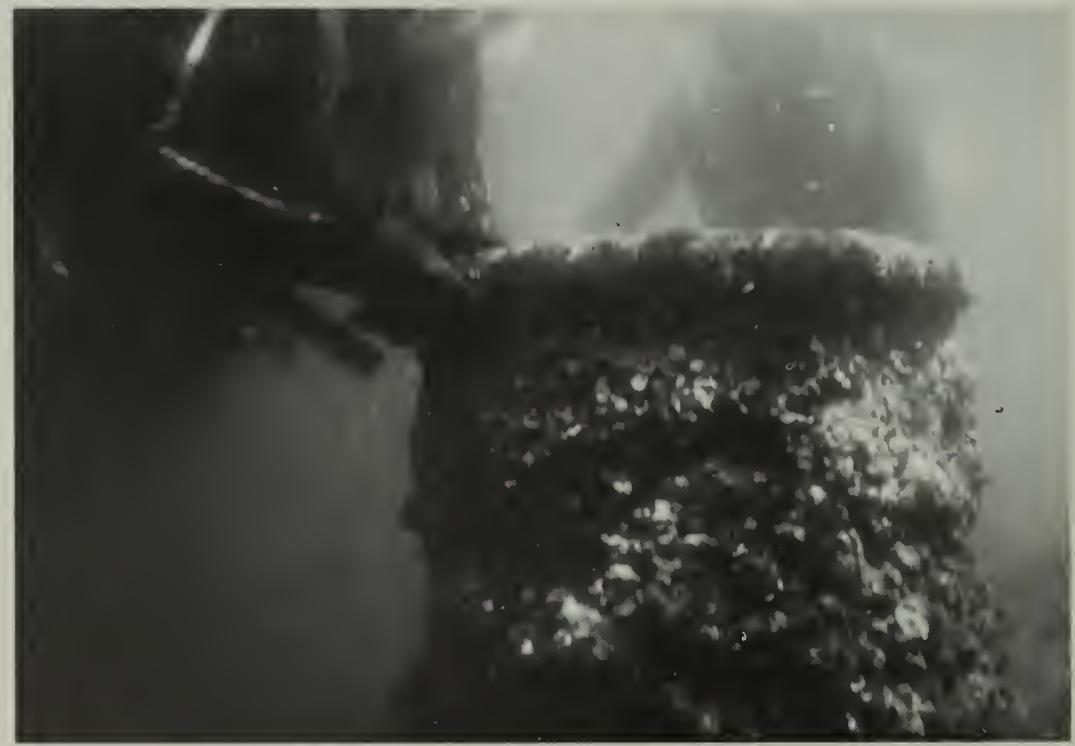
Figure 3.20. Ventilator on deck of USS ARIZONA. (NPS photo by Larry Murphy)

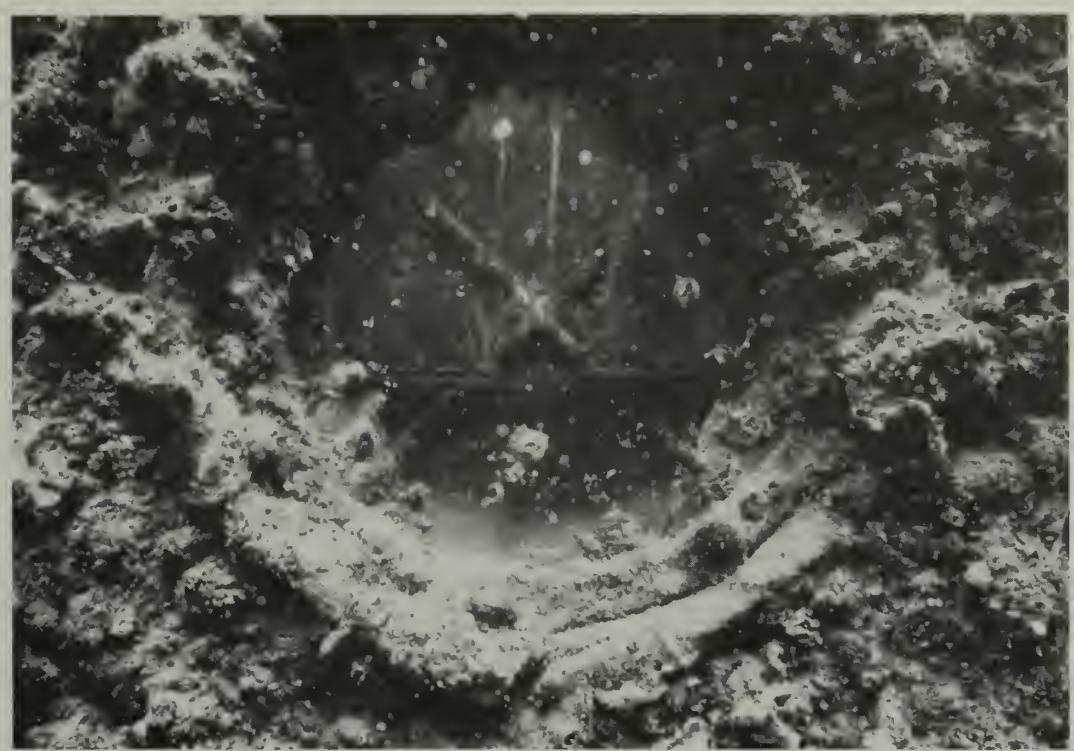
Figure 3.21. Air is trapped between porthole blackout cover and glass on USS ARIZONA. (NPS photo by Larry Murphy)

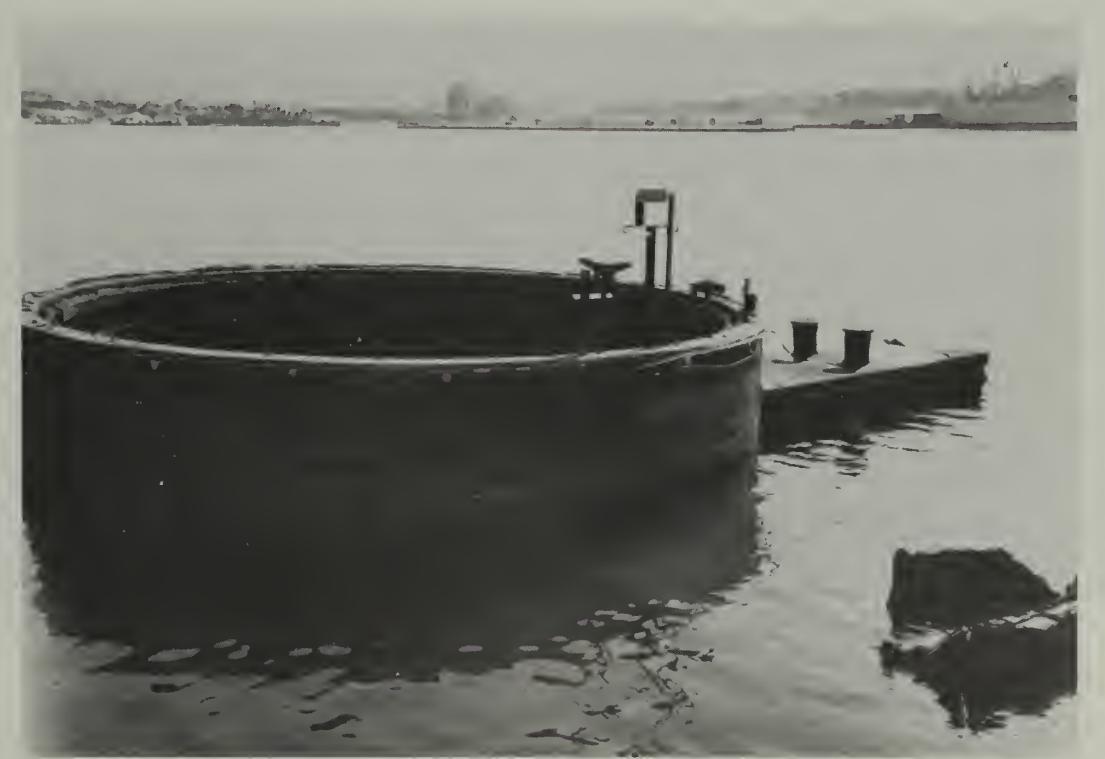
Figure 3.22. No. 3 barbette protrudes higher than any other feature of the ship. (NPS photo by Larry Murphy)

The major changes to the ship aft of the memorial seem to be more the result of Navy salvage than battle damage. The teak-covered main deck was covered forward of the No. 3 turret. All the 14-inch guns have been removed from turrets 3 and 4. An old concrete mooring platform is attached to the No. 3 barbette, which is the largest ship feature above the water (Figure 3.22). Mooring bitts still remain atop the platform.

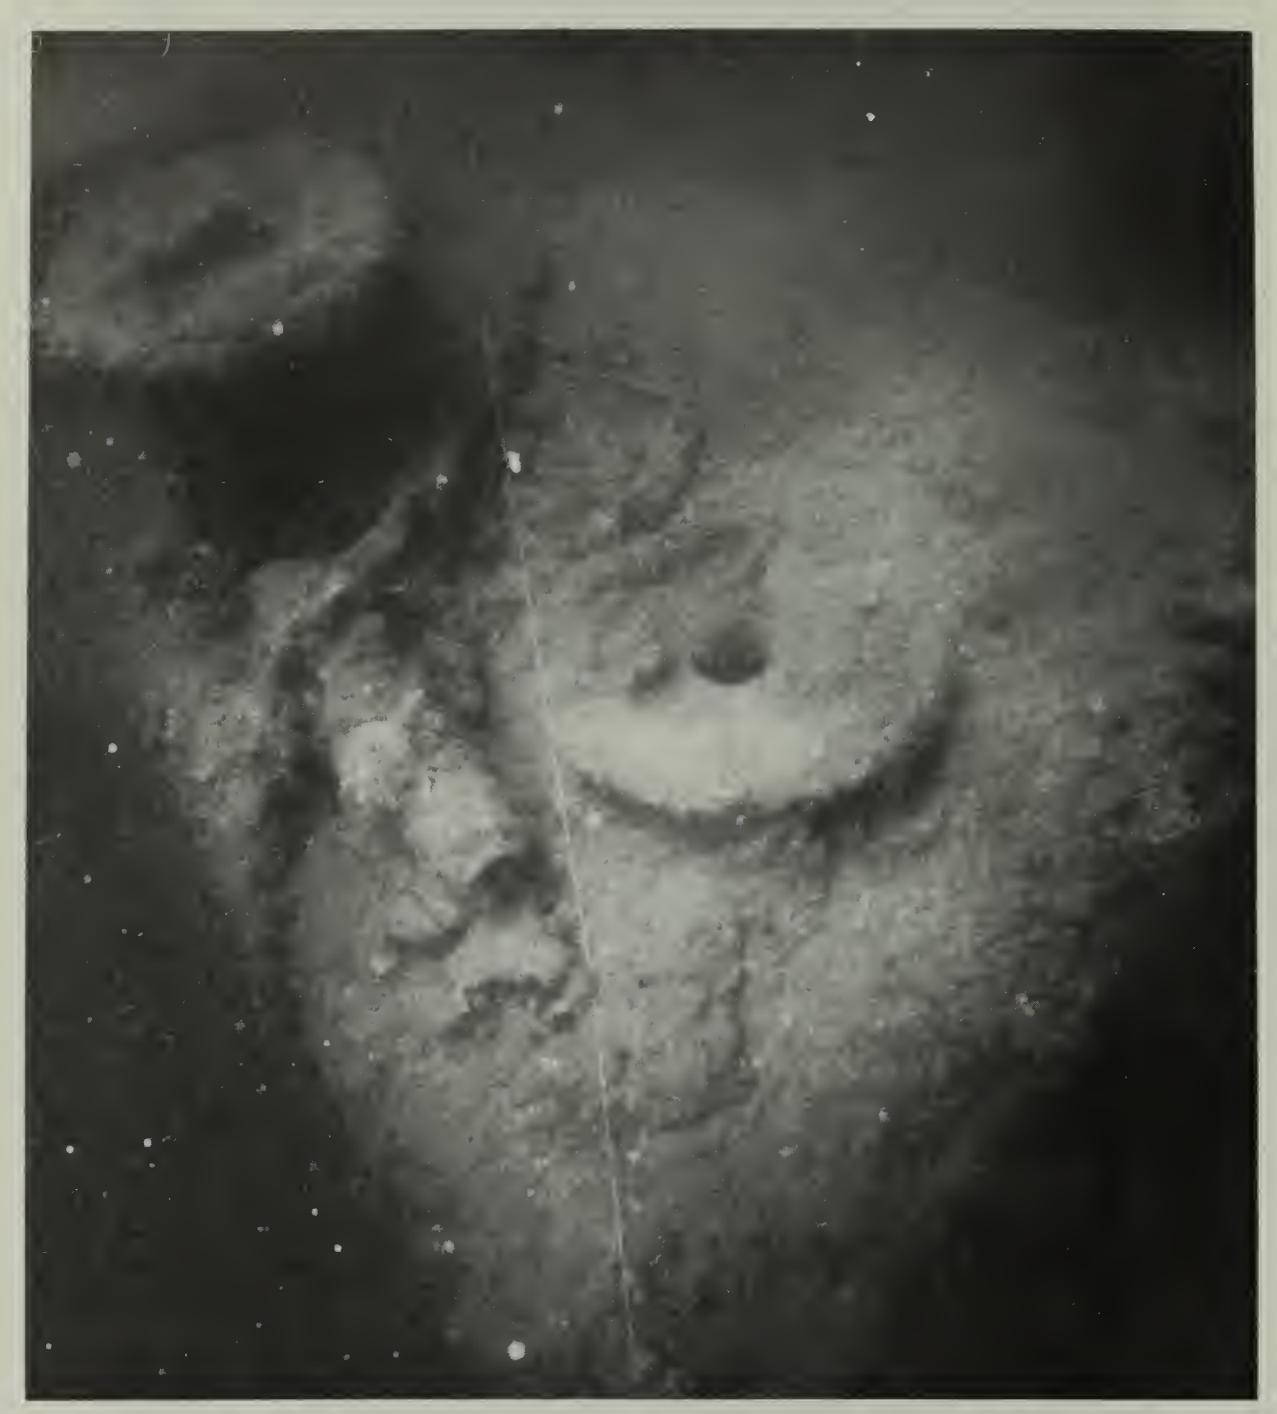
Figure 3.23. Flagstaff hole at stern of USS ARIZONA. Mooring bitts visible to left. (NPS photo by Larry Murphy)

A 12-inch-diameter cable of bundled wire strands can be seen running along the inside of both gunnels in the stern. The function of these cables is unknown, although our original guess that they had something to do with degaussing was not confirmed by military personnel familiar with degaussing technology. The airplane catapult base is visible on the stern. There is a hole in the starboard stern extending to amidships left from the salvage of the airplane recovery crane. On the port stern hull are some portholes that still hold trapped air between the blackout covers and the glass (Figure 3.21); this is the area of the admiral's cabin. The jackstaff hole at the stern is intact, although empty (Figure 3.23).

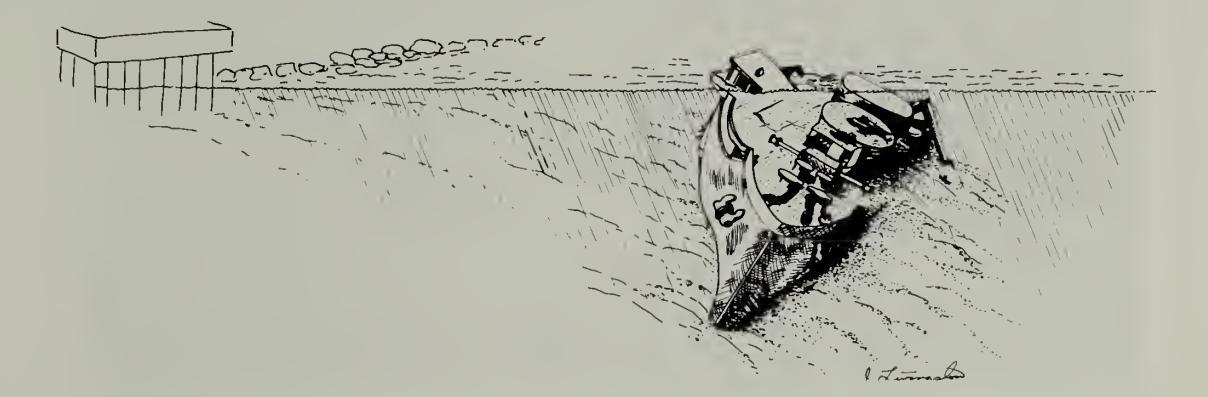
As is evident from the site map (Figure 3.27), the UTAH is lying on its port side and partially buried in the silt. A portion of the starboard side area protrudes from the water amidships and is visible from the memorial. It is interesting that some plants have been able to establish themselves on the hulk, and greenery protrudes from unlikely places on the exposed hull portions.

Figure 3.27. Perspective of Utah from bow by Jerry Livingston.

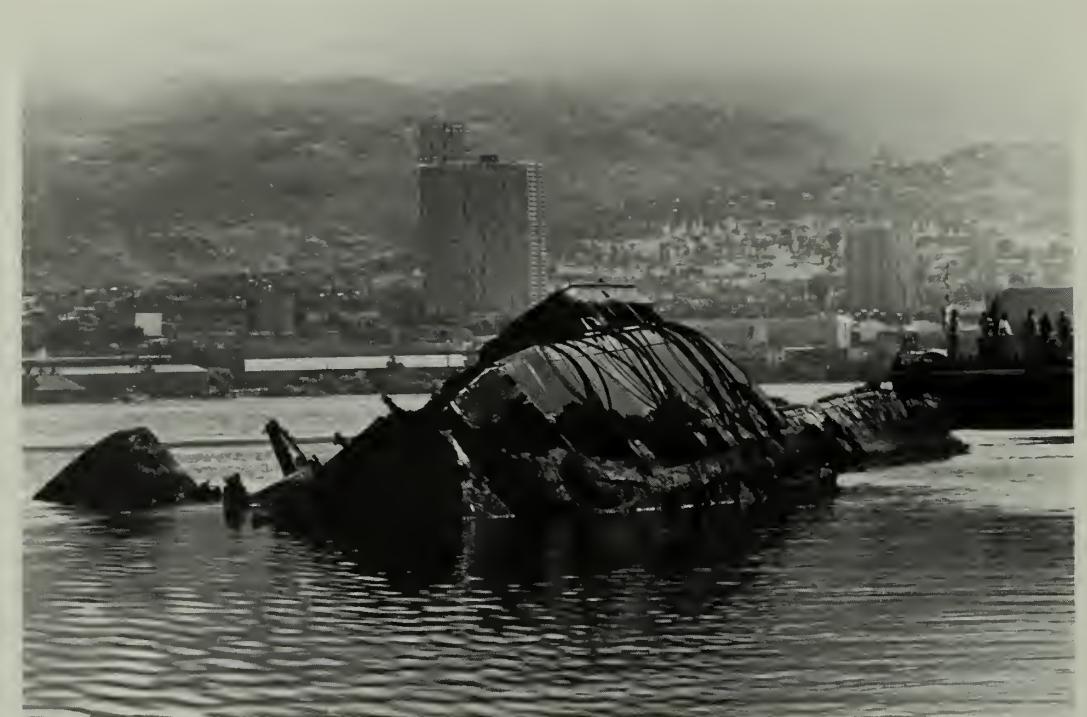
Figure 3.28. USS UTAH looking forward from stern. (NPS photo)

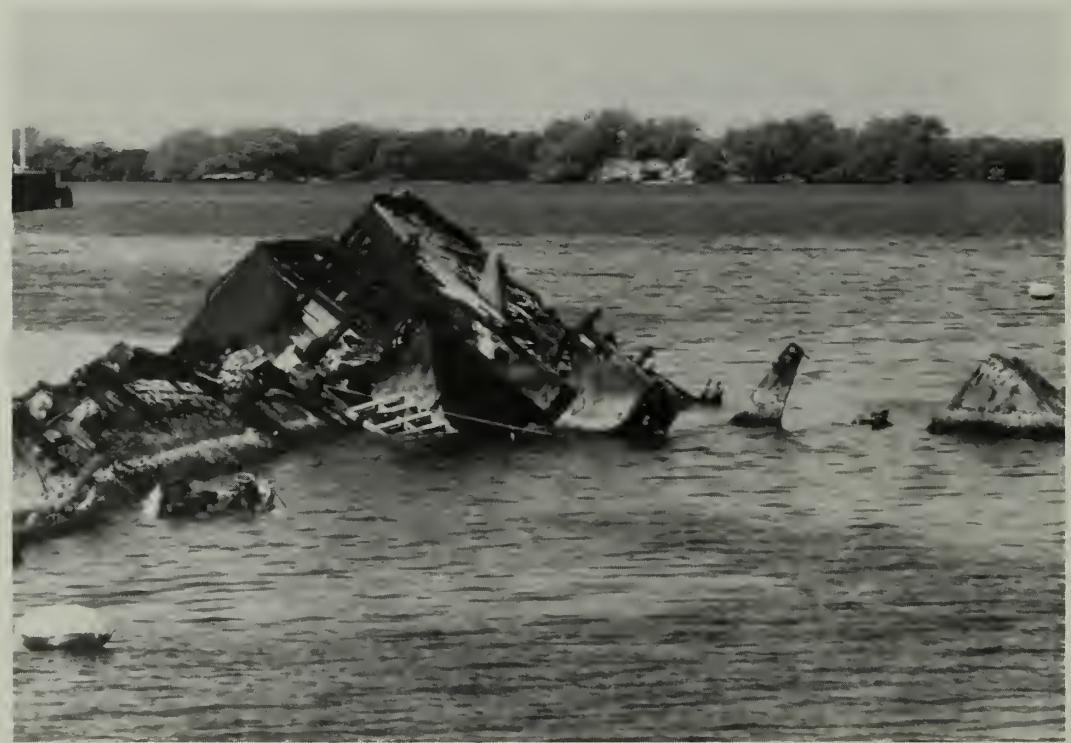
Figure 3.29. USS UTAH looking aft from the bow. (NPS photo)

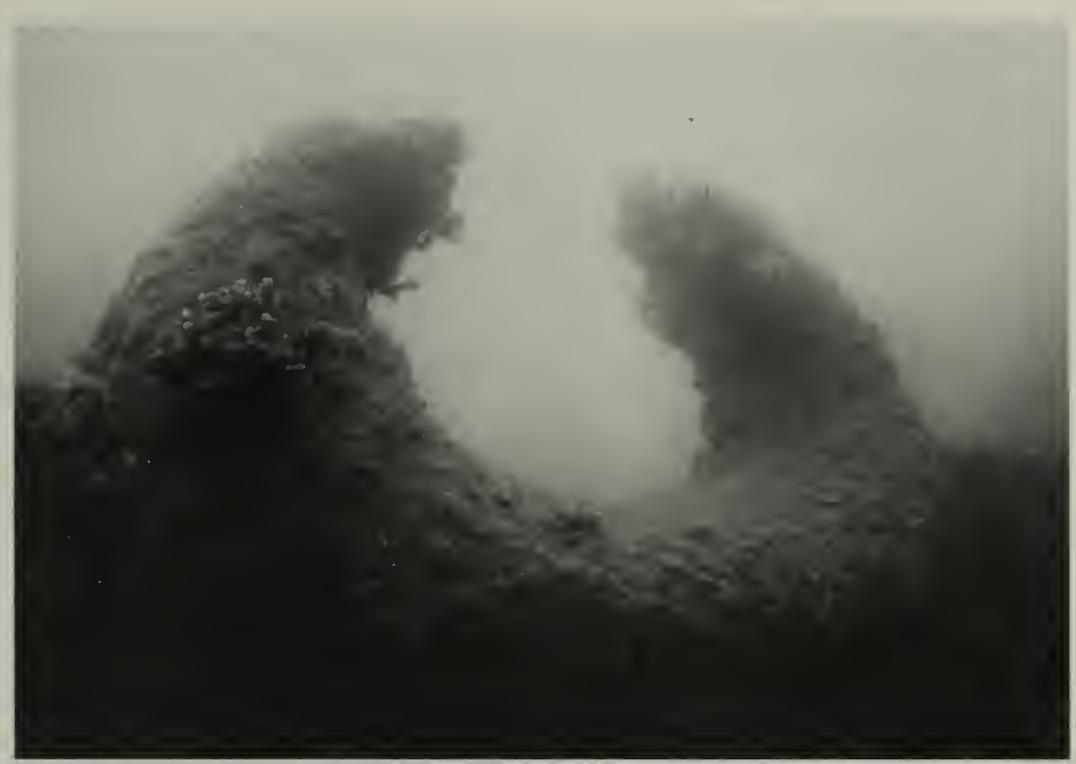
Figure 3.30. Chock on gunnel of starboard bow of USS UTAH. (NPS photo by Larry Murphy)
